23rd Status
March 14, 2008

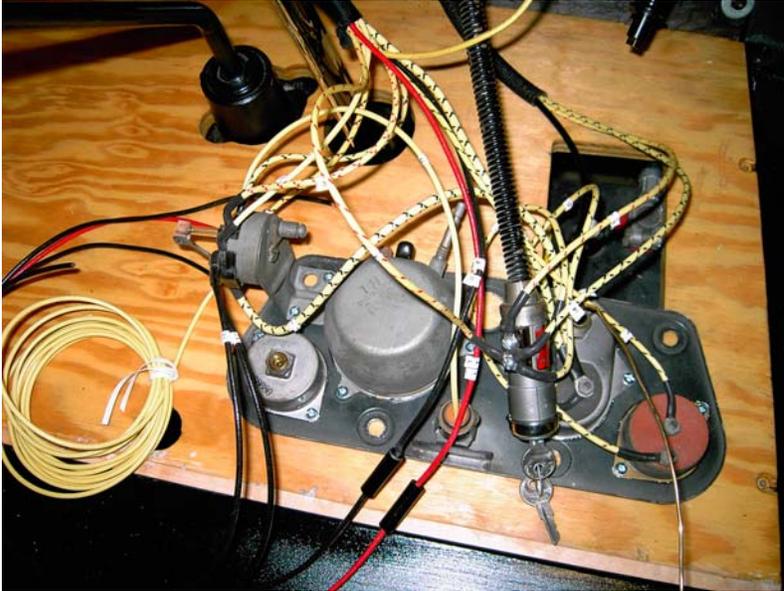
Lots of time was spent with the wiring recently. As you can see in the picture, the instrument cluster is sitting on the floorboard and the wiring harness has been attached.

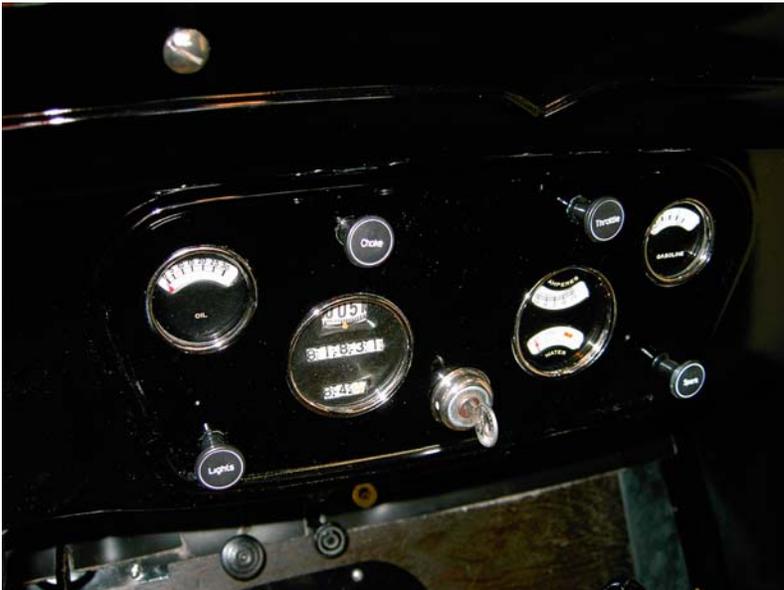
In the picture below, the cluster is finally attached to the back of the dashboard, and the choke, throttle, spark, speedometer, and electro- lock (runs from the ignition switch to the distributor) cables have been installed.
