January 2, 2008  
21<sup>st</sup> Status

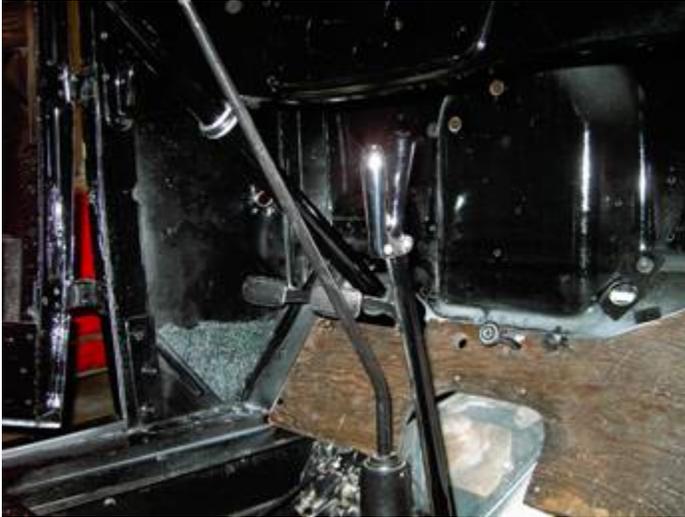
I ordered the cloth webbing that will be tacked around the edges of the floor board and toe board. Thankfully, the original toe board was still in good shape. A new wooden floor board has been varnished, and is ready for the webbing as well. A restored emergency brake handle has now been installed. I had blasted and painted it earlier, and its new spring and nickel plated parts were attached.
