29th Status
September 25, 2008

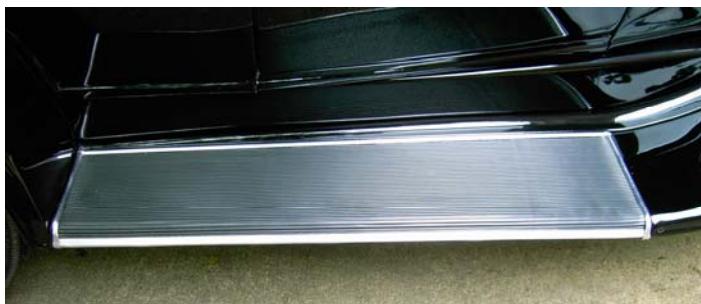
Running boards and trim are now installed. After trying contact cement and rubber cement, 3M's Weatherstrip Adhesive was the product that worked best to glue the rubber to the steel boards. The trim is aluminum and was easily bent. I reordered one piece to replace one that bent during installation and have already installed it.

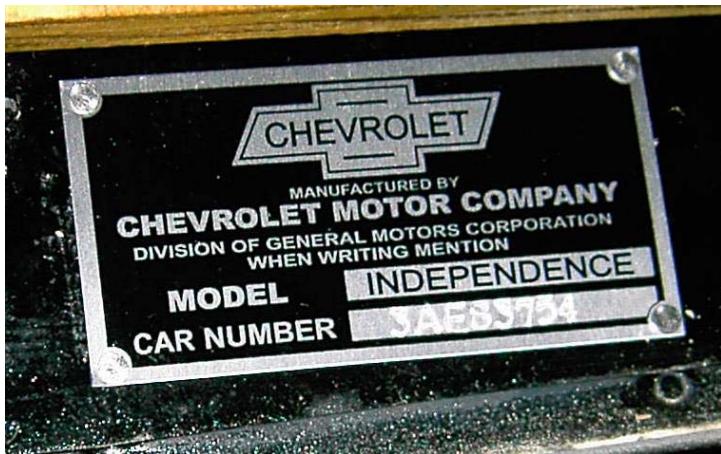
A reproduction identification plate was found on eBay. The original was located on the passenger side wooden main sill of the body, and was apparently destroyed along with the rotten wood. The car's serial number was lost in the process. Legally, it's not a problem, because the car has been registered using its engine number for the last forty years in Mississippi, Texas and Missouri. I knew the car was built in St. Louis, so production figures for that plant for the month of August, 1931 were used to arrive at an approximate number to engrave on the plate. The number "3" is for St. Louis, and AE is for the Independence model.

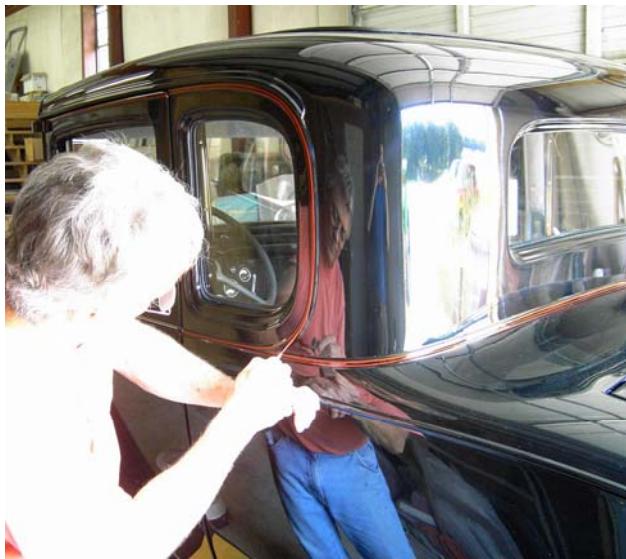
The car was trailered to Tommy's body shop where he completed the final buffing of the body and fenders. The paint is now like a big mirror. The rear bumper was installed, and I chose not to install the trunk rack at this time. The car's trunk is quite large, and it is doubtful that additional trunk space will be needed. The trunk rack is fully restored and will be put away in case it is needed later. Pin striping is now complete. My friend Drennon and I trailered the car to Muscle Shoals, Alabama where Joe Keenum pulled a double red stripe all around the body. Joe did a great job, and the stripes provide a nice contrast.

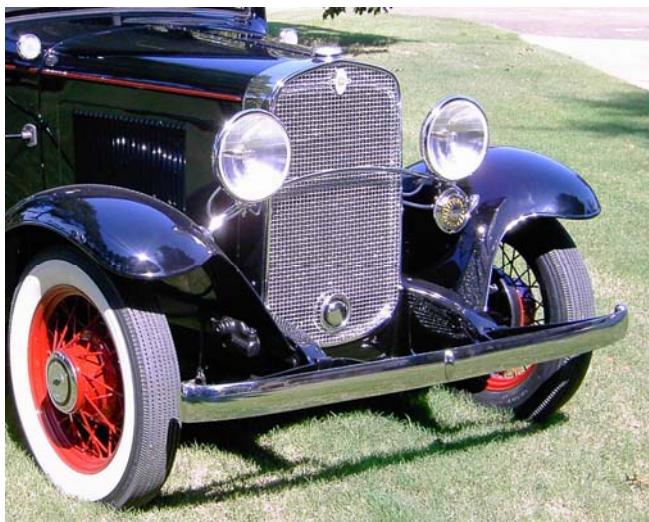
The Alemite pin-type grease fittings were installed all over the chassis, and the restored air cleaner was installed on the carburetor. A new clutch pedal return spring was installed, and the pedal shafts were lubed with silicone grease. Double clutching will be much easier, now that the pedal doesn't stick to the floor! Headlights, cowl lights and horn are installed. Each had its challenges. The headlights were adjusted using marks on the garage wall as a guide. They are brighter than I expected, probably because of the special aluminum coating that was used on the reflectors. After bolting the cowl lights in place and wiring them, the rims were impossible to attach. I then realized that when the mounting bolt was tightened, it distorted the lamp such that the rim wouldn't fit. Loosening the mounting bolt made it possible to attach the rim. The restored horn didn't beep when connected. Considerable time was spent attempting to adjust it, and only a faint beep resulted. The supplier agreed to take it back and repair it, but I'll wait until after the car shows are over this fall to remove it.
