July 15, 2007
16th status

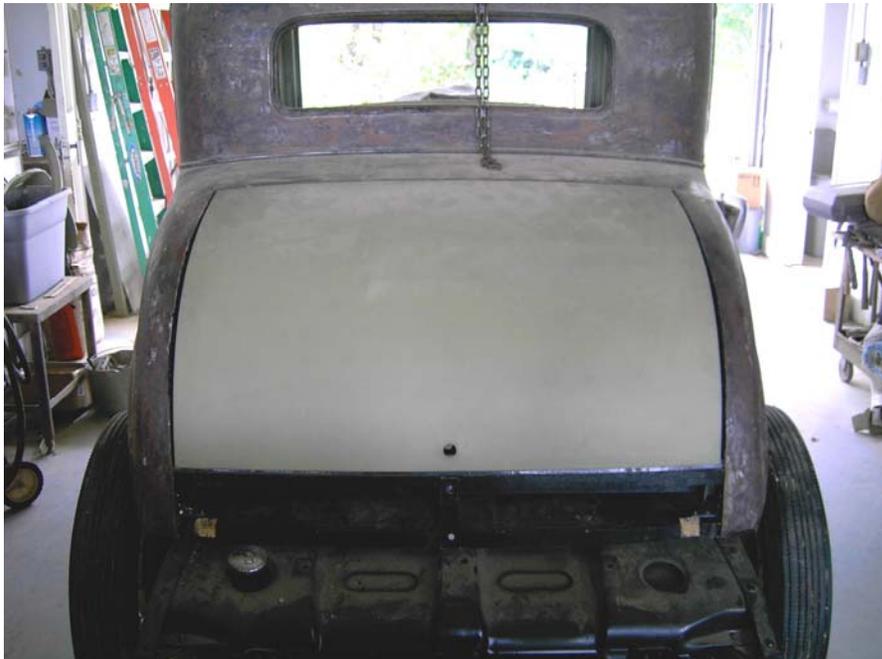
Because the sheet metal at the bottom of the body is to be tacked to the bottom of the wooden kick-up assemblies, I re-fitted the patch panels in that area to assure proper line-up. The trunk lid did not fit well, and I spent a few days adjusting everything I could find that might affect it. Finally, Tommy suggested pulling the bottom of the body with a heavy tie down strap. That did the trick! The trunk lid now lines up well on both sides, and it opens and closes nicely.

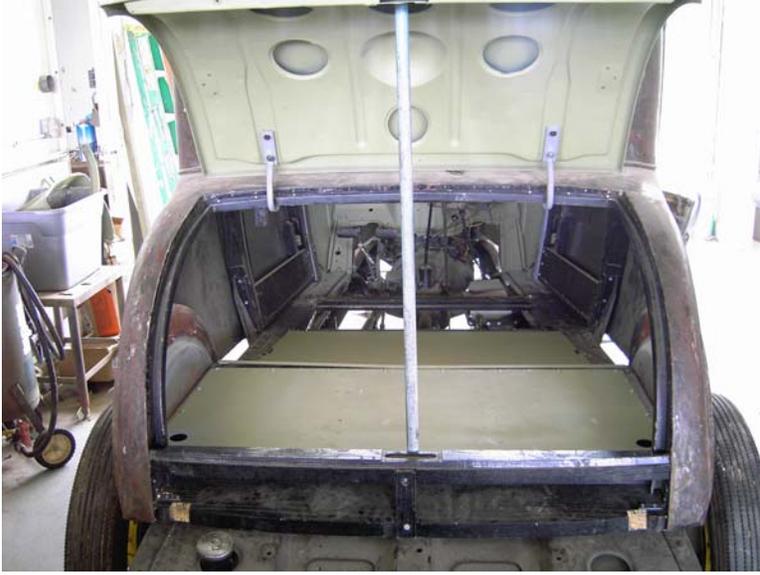
The sheet metal trunk floor pan also fits properly and has been screwed and tacked into place. The similar floor pan that mounts in front of that also fits well, and I will screw it into place soon.

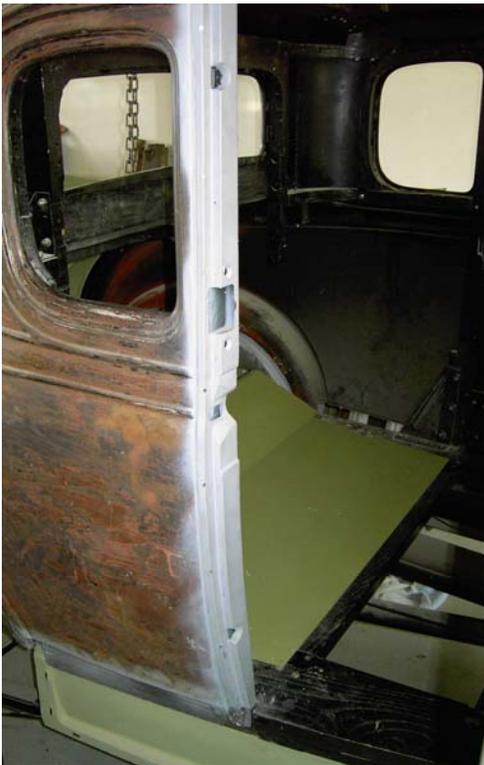
I spent an afternoon adjusting the sheet metal trim piece that covers the passenger door's wooden latch post. I had to file off a small portion of one corner, and I used a Dremel tool to re-shape one area of the wood. It now fits properly and has been tacked into place. The door opens and closes nicely. Soon I will attach the metal guideplate assembly to the post.
