17th status

It suddenly looks like a car!

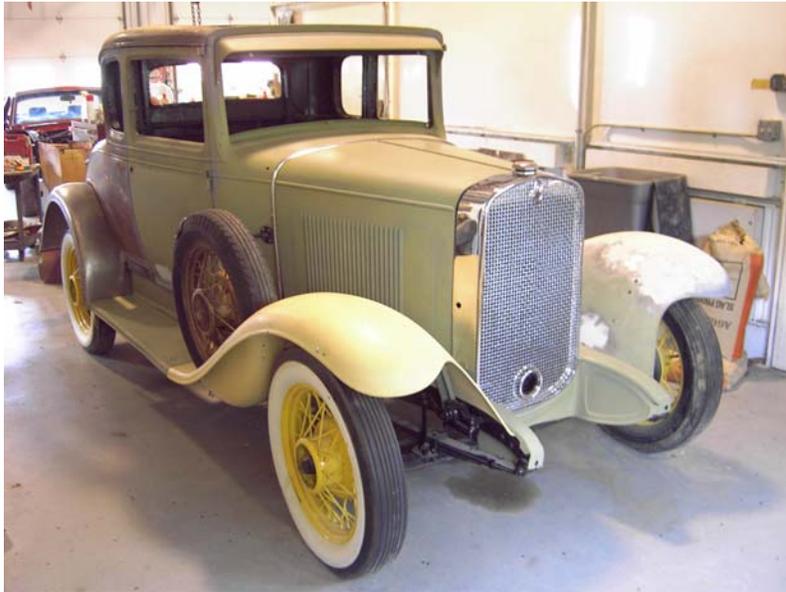
I installed the fenders, running boards, and side mounted spares to check for final fit before painting. The mounting holes in the reproduction rear fenders had to be enlarged slightly, but after that, everything lined up properly.

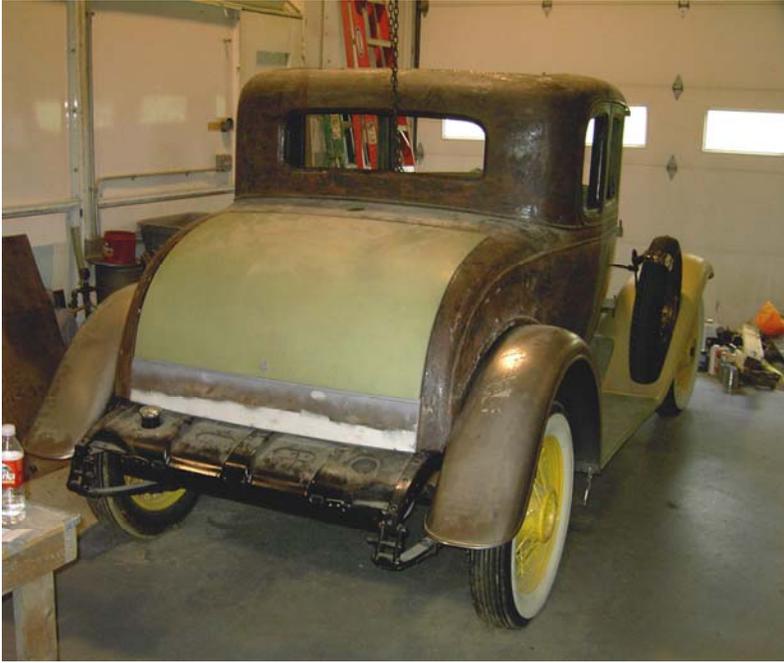
I've removed the rear fenders and firmly secured the wheel well patch panels with pop rivets. Tommy will weld the panels in place later, and I'll drill out the pop rivets.
