28th Status

August 26, 2008

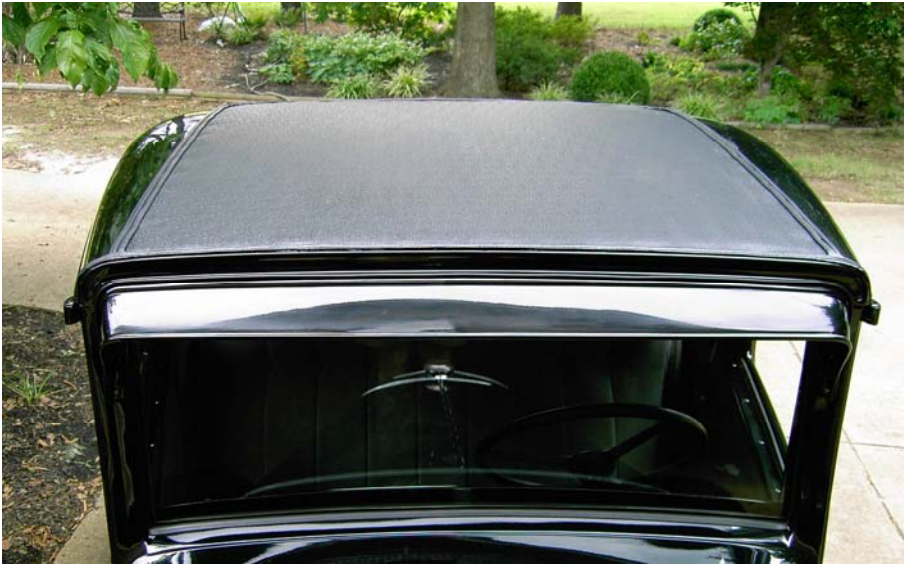
The top is complete, but it wasn't fun. A few frustrating days were spent dealing with the reproduction aluminum tacking strips. Bending the aluminum was the first challenge, and after several hours, I was still not satisfied that it would look right. There was also the concern that the aluminum would slip during installation, and damage the car's beautiful paint job. Even though it is not as original, I decided to use the wire-on and hide-um that were included with Hampton Coach's top kit. It was much easier to install. If original tacking strips or pre-bent tacking strips are located later, I'll try that approach again.

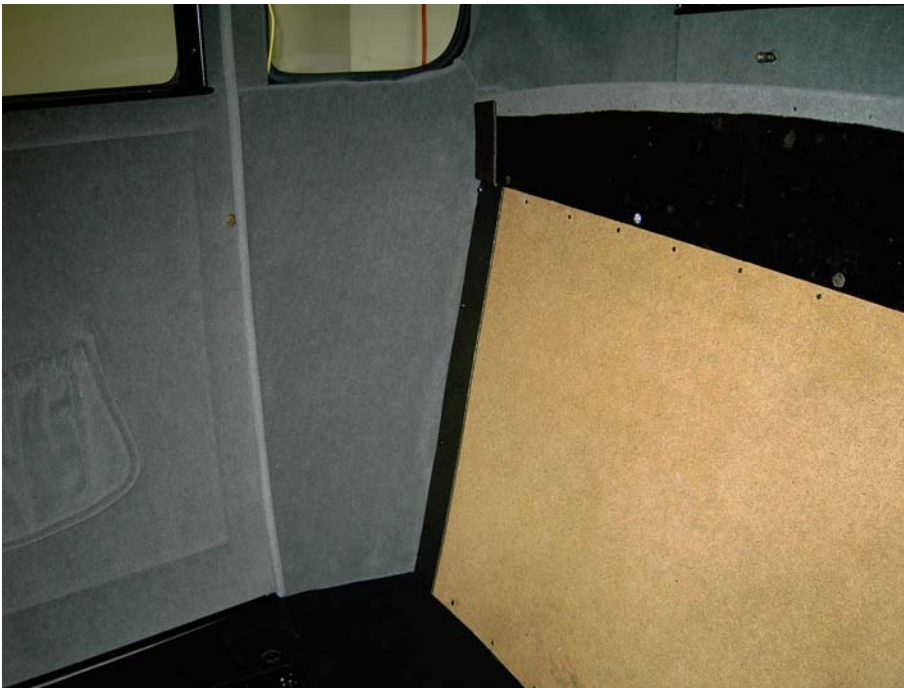
The rest of the upholstery panels have been installed. The roof corner panels were a big challenge. These are the panels that fit between the back window and the quarter windows. The cardboard in these panels had to be bent into the curve of the top in that area as they were tacked (with wire brads) into place, and like most of the other panels, had to be blind nailed. The pillar panels included in the kit were too short. These panels fit between the door post and the trunk front panel. Longer panels were

fabricated out of cardboard and additional mohair was ordered to cover them. Another challenge was the long thin panels covered in black leatherette that were included in the kit. The instructions weren't clear and the Hampton Coach folks weren't sure where they should be attached. Their shape indicated they might fit on either side of the trunk front panel, and installing them there would cover a bare wood area that was just barely visible on either side of the seat when it is installed. So, that is what I did. To install the panels, I cut off the top 3 inches and installed the remaining lower portion in the recessed area on either side of the trunk front panel. New cardboard panels about 4 inches long were cut, covered with leatherette and attached at each end of the package tray. A yard of plain rubber was purchased at a local hardware store and cut to fit the floor in the area behind and beside the seat.

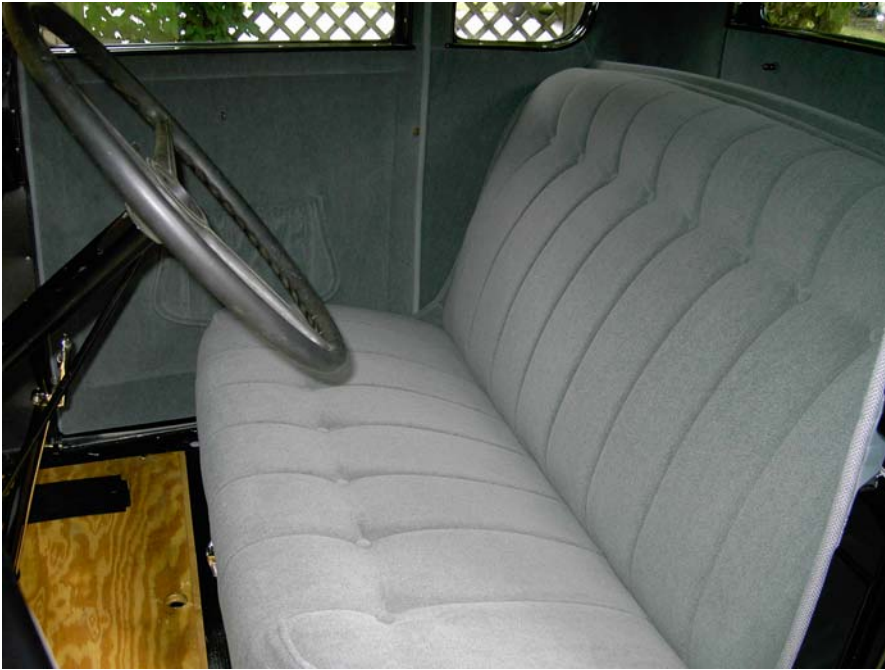
The seat is now installed, and it looks great! Walt's Upholstery Shop did a fantastic job. An unexpected additional task was the rebuilding of the seat bottom spring assembly. The new assembly purchased from Hampton Coach was three inches narrower (from side to side) than the original, so Walt rebuilt the original one.
