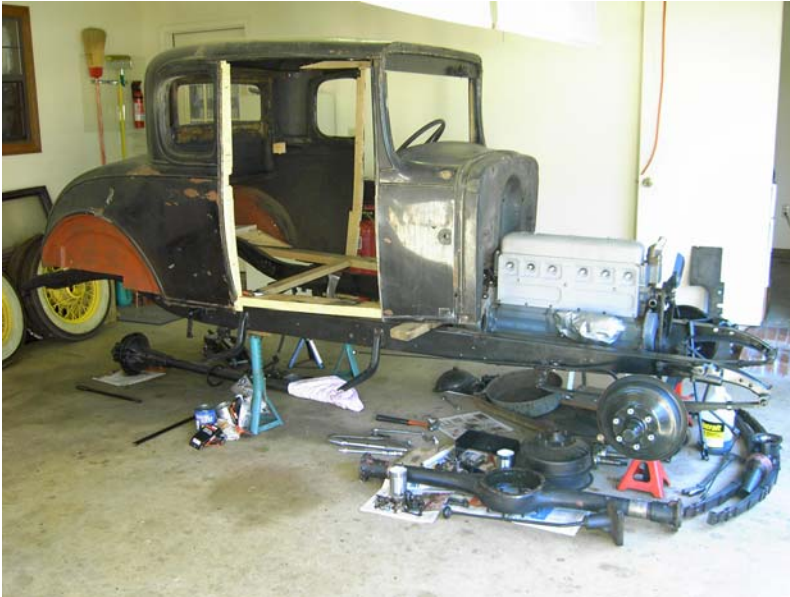
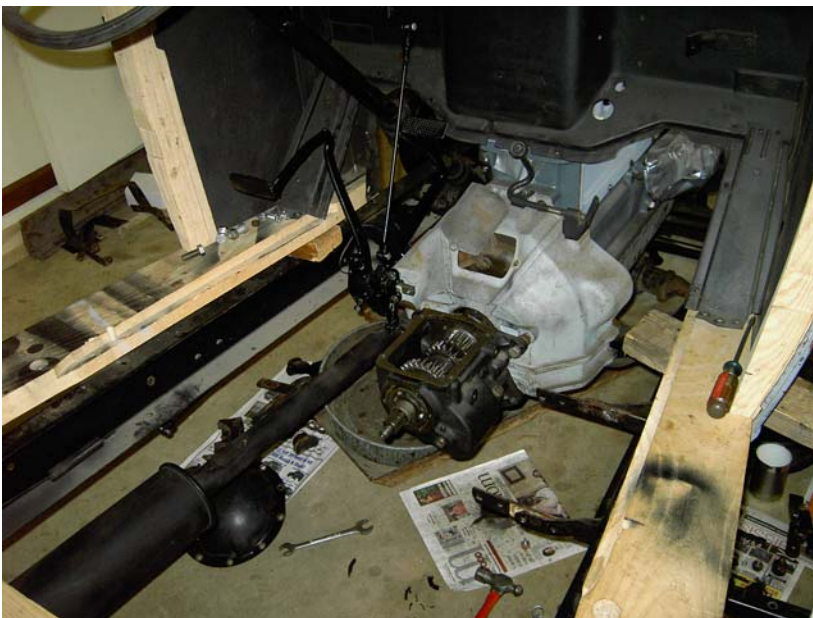
3rd status - the brakes have been re-lined, and brake drums have new bearings installed. All 4 brake shoe systems have been re-assembled. The front brake systems and drums have been installed and now appear to work. I took out the rear end housing and rear springs and degreased them. I identified a mystery piece as a cross member that goes under the battery box and installed it. Unfortunately, the battery box was then too deep, so I shortened it, drilled new holes, re-painted and mounted it. Since then I have removed everything in the chasis aft of the transmission, to remove the transmission. However, it is still stuck to the bell housing. Apparently, it was forced on and will not come off easily. The wear pattern on the gears makes me think it will be noisy in 1st and 2nd, so it's got to come off. I'll try using threaded rods and nuts to get it off the bell housing. A friend has offered me a '32 trans that would be synchronized, but I will have to shorten my driveshaft to make it fit. I'll look at it next week and decide. If I don't go for the '32 trans, he has a friend who may have other 29 -31 transmissions. At a minimum, I'll find some replacement gears for mine.
